Accessibility Survey

Americans with Disabilities Act

Dac Technologies Corporation

54321 Compliance Lane
Accessibility, CA 94568

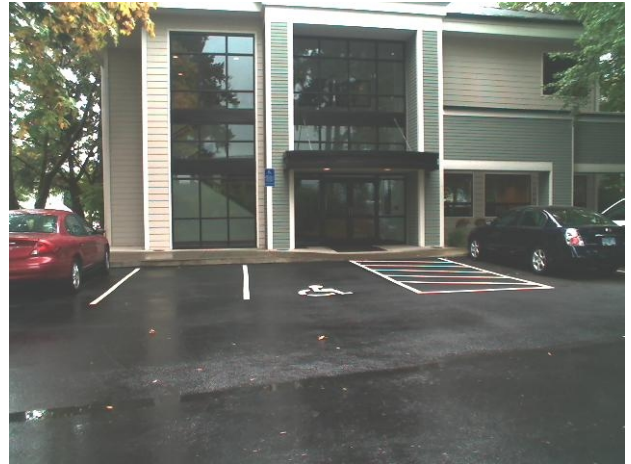
Parking Lot , Parking Space : Required Minimum Van Accessible Spaces

There is no designated "van-accessible" parking space provided in the parking lot.

On-Site Finding None Found

ADAAG 4.1.2(5)

CA 1129B

Provide a compliant van accessible space.

Create accessible space by restriping and \$370 adding a post mounted sign.

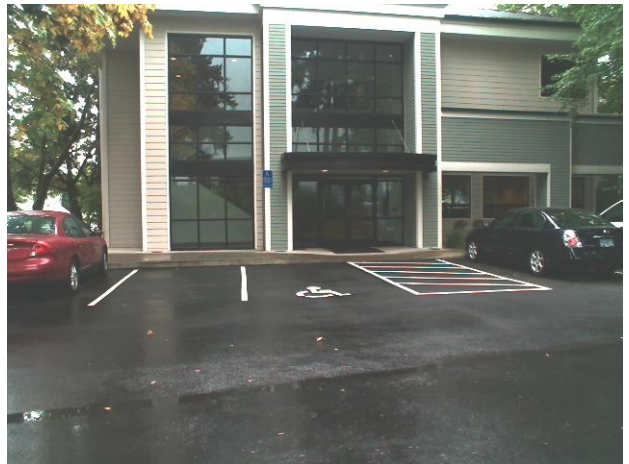
Parking Lot : Less Than Minimum Required Parking Spaces

There are not enough accessible parking spaces marked in the parking lot and therefore does not meet the minimum number required.

On-Site Finding 1.00 spaces

ADAAG 4.1.2(5)

CA 1129B

Re-stripe any existing parking spaces marked accessible and create additional accessible parking spaces. Designate one parking space as "van-accessible". The van-accessible space shall provide an access aisle on the passenger side (right side) of the vehicle space. The additional parking spaces shall each provide an access aisle that may be shared.

Paint ground markings and install a post mounted sign. \$370

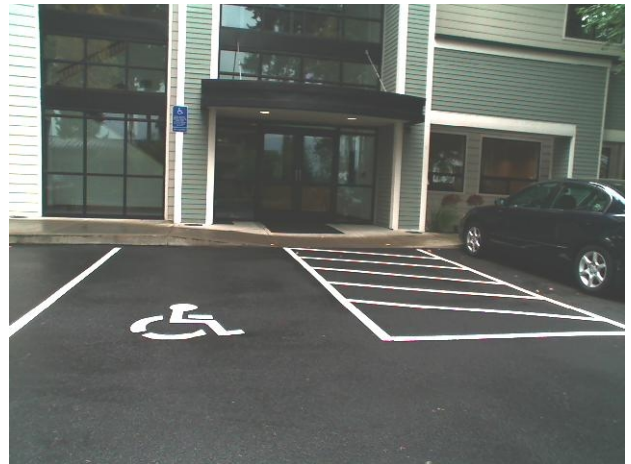
Parking Lot , Parking Space : Parking Space Slope

The surface of the accessible parking space has a slope greater than allowed.

On-Site Finding 4.80 percent

ADAAG 4.6.3

CA 1129B.4.4

Pave the parking lot to provide a level surface.

Repave surface to correct slope and restripe. \$2,900

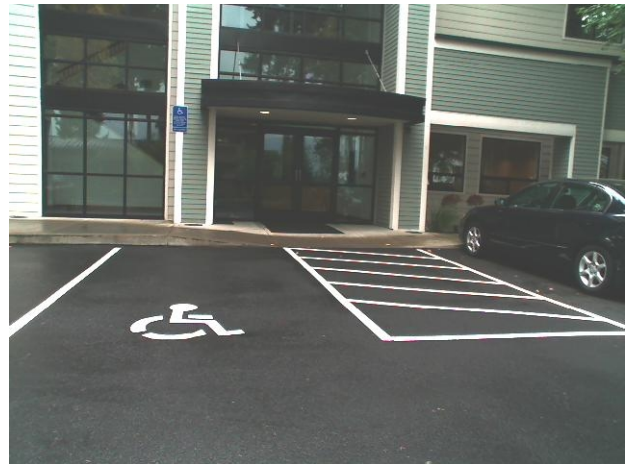
Parking Lot , Parking Space : Parking Space ISA Contrast

Pavement markings at the designated accessible parking spaces do not profile a view of the white on blue International Symbol of Accessibility.

ADAAG 4.6.4

CA 1129B.5

Each designated accessible parking space shall be identified with a pavement marking consisting of outlining the accessible space in blue and outlining an ISA symbol in white; or outlining a 36 inch by 36 inch white on blue ISA symbol positioned where it can be viewed when a vehicle is parked in the space.

Stripe an access aisle. \$220

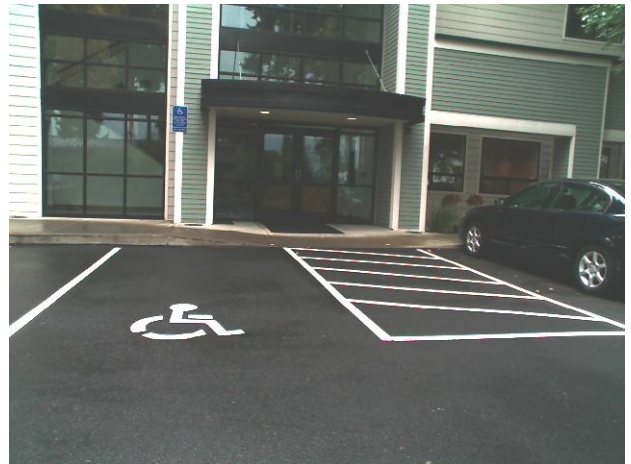
Parking Lot , Parking Space : Parking Space ISA Size

Pavement markings at the designated accessible parking spaces do not measure 36 inches by 36 inches.
On-Site Finding 28.00 inches

ADAAG 4.6.4
CA 1129B.5

Each designated accessible parking space shall be identified with a pavement marking consisting of outlining the accessible space in blue and outlining an ISA symbol in white; or outlining a 36 inch by 36 inch white on blue ISA symbol positioned where it can be viewed when a vehicle is parked in the space.
Recommended At least 36.00 inches

Stripe an access aisle. \$220

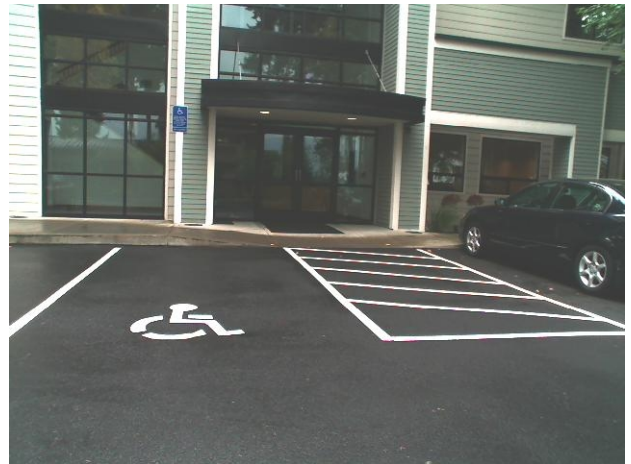
Parking Lot , Parking Space : Access Aisle Slope

The access aisle exceeds maximum slope.

On-Site Finding 4.80 percent

ADAAG 4.6.3

CA 1129B.4.4

Pave the parking lot to provide a level surface.

Repave surface to correct slope and restripe. \$2,900

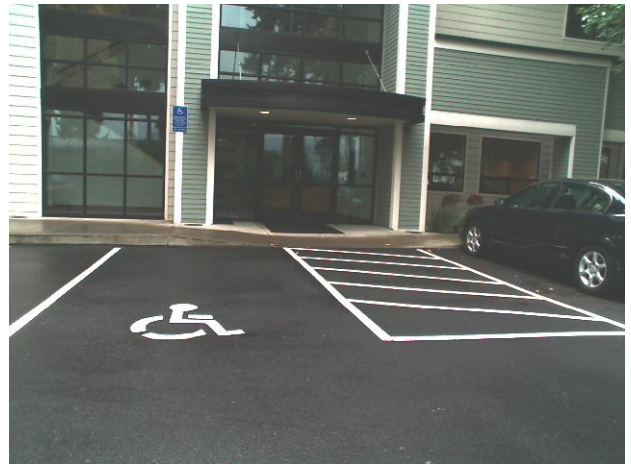
Parking Lot , Parking Space : Parking Space Width

The accessible parking space does not meet the minimum requirements for width.

On-Site Finding 95.00 inches

ADAAG 4.6.3

CA 1129B.4

Re-stripe the accessible parking space.

Re-stripe existing parking space. \$117

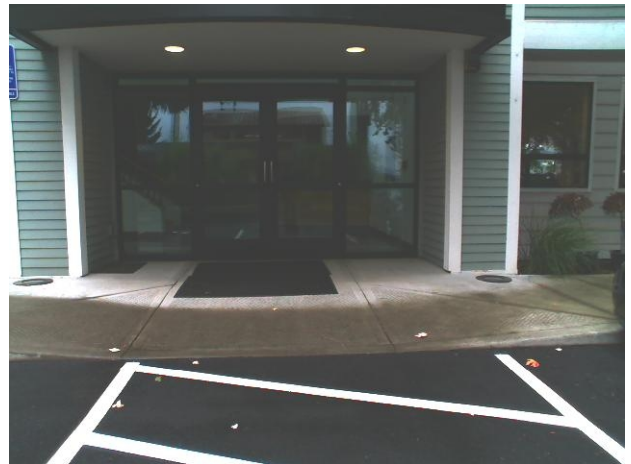
Curb Ramp : No Detectable Warnings

The curb ramp does not provide a detectable warning surface which includes truncated domes.

On-Site Finding Not Found

ADAAG 4.7.7

CA 1127B.5.8

Provide compliant detectable warnings to surface.

Provide detectable warning to surface. \$144

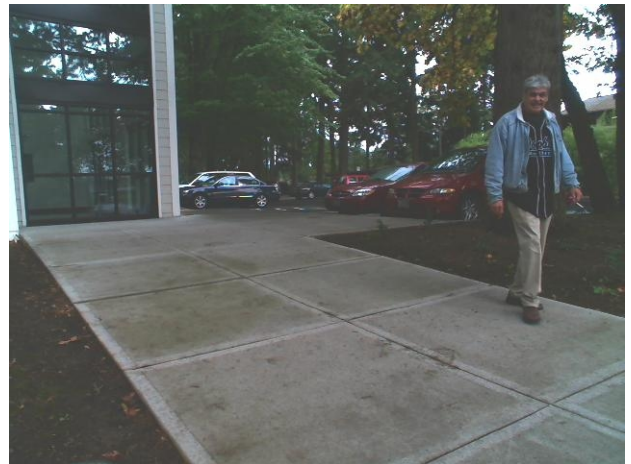
Path Of Travel , Walking Surfaces : Walking Surface Slope

There are slopes greater than allowed maximum slope on the primary path of travel.

On-Site Finding 9.00 percent

ADAAG 4.3.7

CA 1133B.7.3

Provide compliant sidewalk.

Install compliant pathway. \$1,840

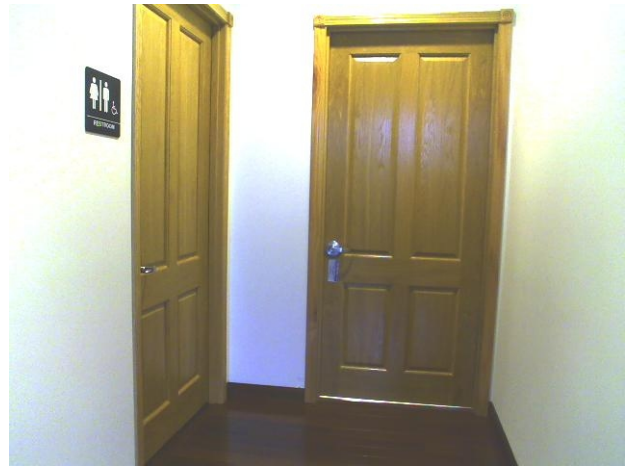
Door , Clear Floor Space : Latch Approach Clear Floor Space Width

There is not enough clear floor space provided at the pull side of the door.

On-Site Finding 48.00 inches

ADAAG 4.13.6

CA 1133B.2.4.2

Provide the recommended clear floor space on the pull side of the door.

Install automatic door opener. \$2,921

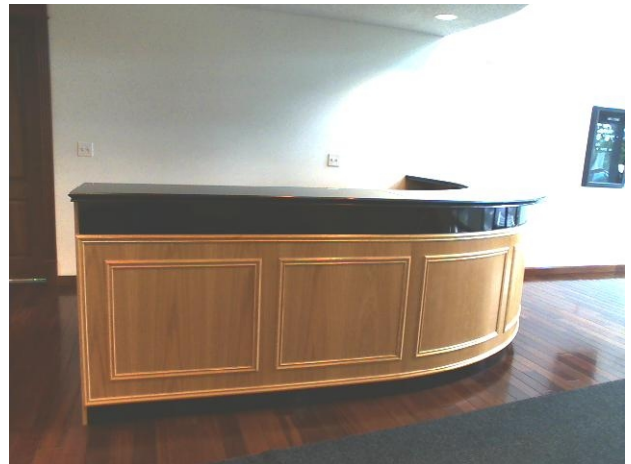
Counter : Counter Height

The height of the counter or desk does not comply with height requirements. No equivalent facilitation is provided in the area.

On-Site Finding 38.00 inches

ADAAG 4.32.4

ADAAG 7.2

CA 1122B.4

Make sure a portion of the counter or desk is at the compliant height range.

Provide compliant counter. \$545

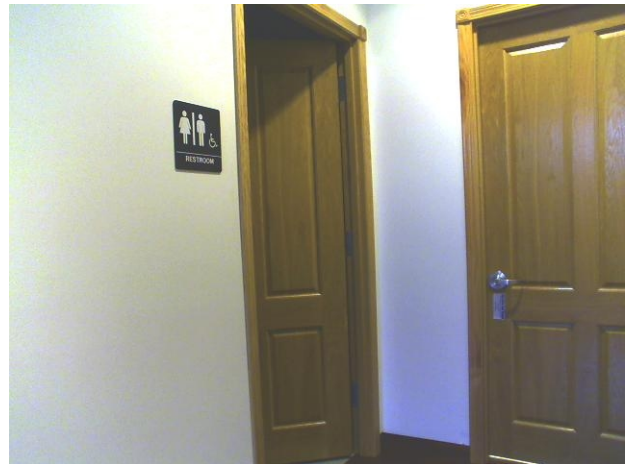
Restroom , Wall Signage : Wall Signage Height

The signage is not mounted at the required height.

On-Site Finding 61.00 inches on center

ADAAG 4.30.6

CA 1117B.5.7

Post signage designating the restroom as accessible. Signage shall be mounted at the required height and location and shall include Braille, raised lettering, the ISA symbol and gender use pictogram.

Provide compliant signage. \$158

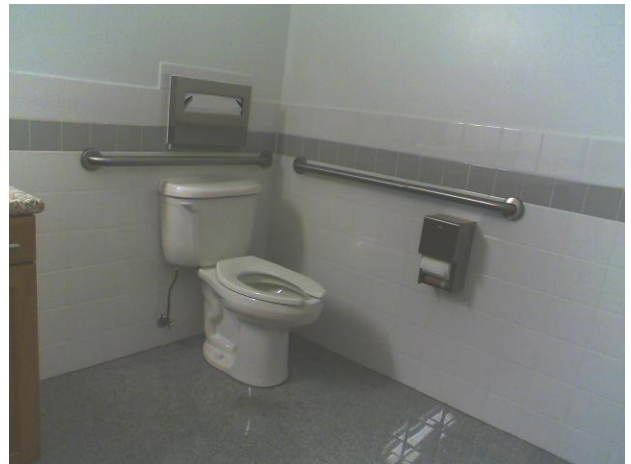
Restroom , Grab Bars : Back Grab Bar Height

The grab bar on the back wall is not at the correct height.

On-Site Finding 34.00 inches

ADAAG 4.16.4

ADAAG 4.17.6

CA 1115B.8.1

Remount the back grab bar in the compartment designated to be accessible so the height of the gripping surface is at the correct height.

Provide compliant grab bar. \$231

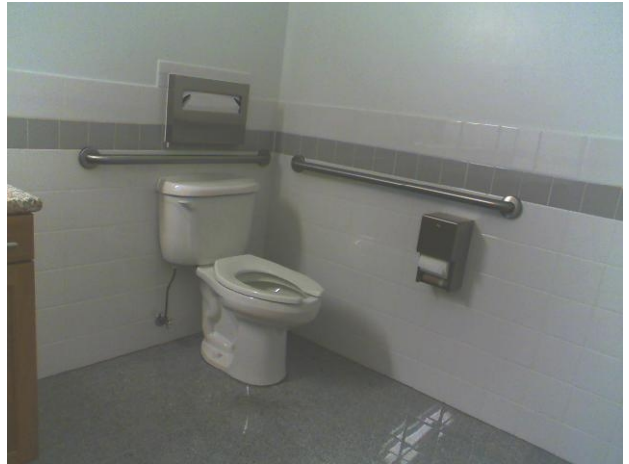
Restroom , Toilet Compartment : Toilet Paper Dispenser Distance From Seat

The location of the toilet paper dispenser is not within the required distance from the front edge of the toilet seat.

On-Site Finding 14.00 inches

ADAAG 4.16.6

CA 1115B.9.3

Remount the toilet paper dispenser so it is within the required distance from the front edge of the toilet seat. Toilet paper dispensers must allow continuous paper flow and shall not interfere with the use of the side grab bar.

Provide compliant dispenser. \$277

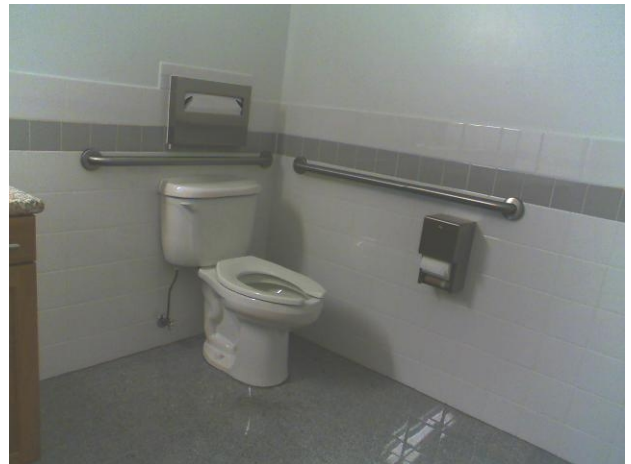
Restroom , Toilet : Toilet Distance From Wall

The distance from the center of the toilet to the nearest side wall does not meet the required distance.

On-Site Finding 19.00 inches on center

ADAAG 4.16.2

CA 1115B.7.1.3

Relocate the toilet so the distance from the centerline of the toilet to the nearest side wall meets the required distance.

Relocate fixture. \$1,143

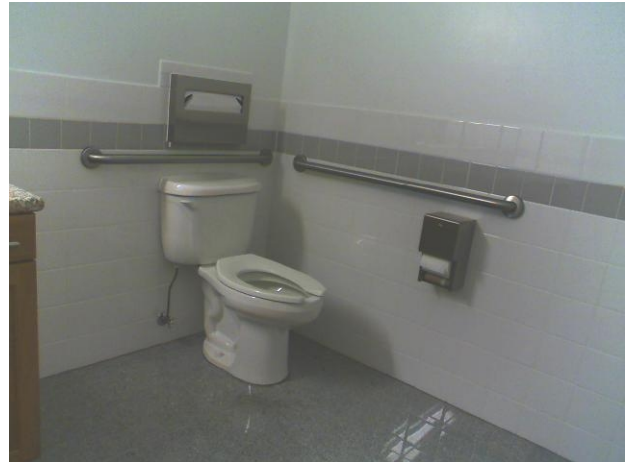
Restroom , Grab Bars : Side Grab Bar Height

The height of the side grab bar is not at the correct height.

On-Site Finding 34.00 inches

ADAAG 4.16.4

ADAAG 4.17.6

CA 1115B.8.1

Remount the grab bar so it is at the correct height.

Provide compliant grab bar. \$231

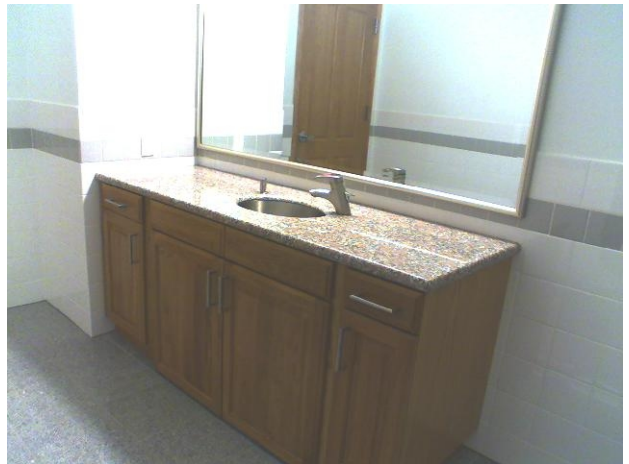
Restroom , Lavatory : Lavatory Type

The lavatory is in an enclosed cabinet, thereby preventing an accessible forward approach.

On-Site Finding Not Accessible

ADAAG 4.19.2

CA 1115B.2.1.2

Lavatories in restrooms must provide clear floor space in front of the lavatory for an accessible forward approach and shall provide at least 29 inches clear knee space and a minimum of nine inches clear toe space. If neither clear floor space and knee and toe clearance can be provided, remove the lavatory cabinet and replace with an accessible wall-mounted lavatory unit.

Remove base cabinets, add additional \$420
bracing.

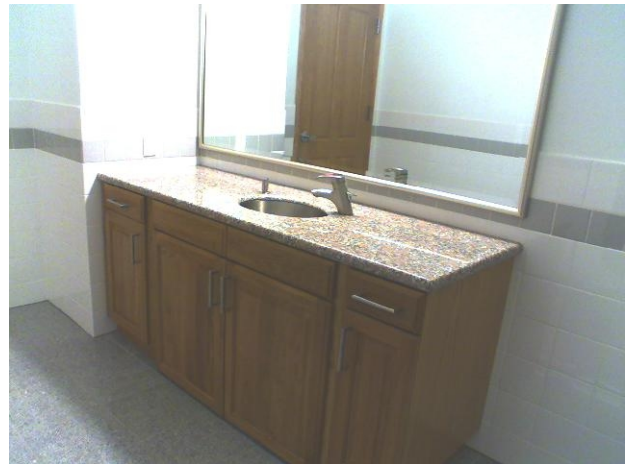
Restroom , Lavatory : Lavatory Surface Height

The height of the counter surface is greater than allowed.

On-Site Finding 36.00 inches

ADAAG 4.19.2

CA 1115B.2.1.2

Relocate or replace the lavatory to provide a maximum counter surface height of no greater than recommended.

Provide compliant sink. \$1,286

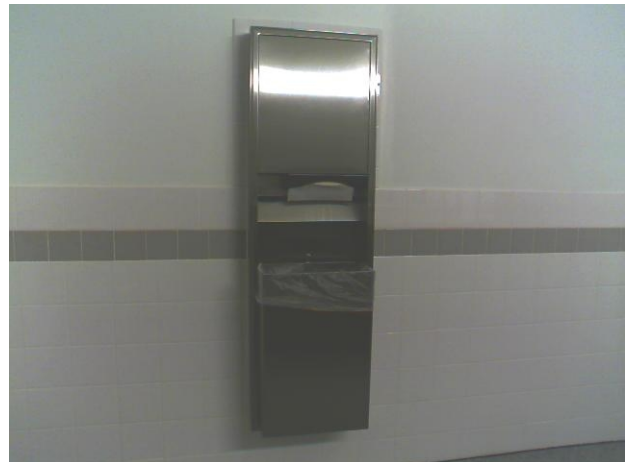
Restroom , Dispensers : Dispenser Height

The height of the controls and operating mechanisms for the dispenser is not at the correct height.

On-Site Finding 45.00 inches

ADAAG 4.22.7

ADAAG 4.23.7

CA 1115B.9.2

Relocate the dispenser to the correct height.

Provide compliant dispenser. \$277

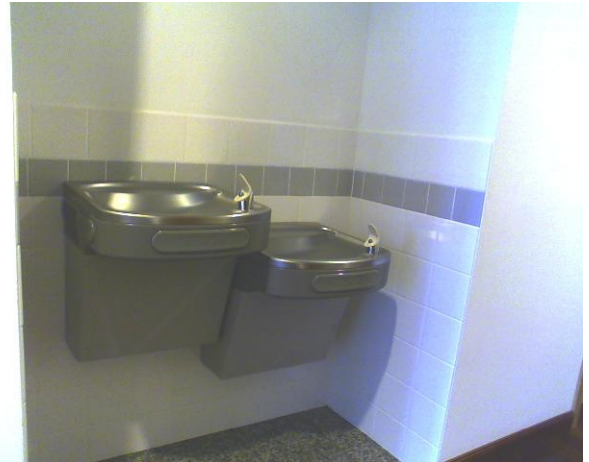
Drinking Fountain : Stream Height

The height of the water stream is less than 4 inches.

On-Site Finding 1.00 inches

ADAAG 4.15.3

CA 1115B.2.1.5.4

The spout shall direct the water flow at least 4 inches high and in a trajectory that is parallel or nearly parallel to the front of the drinking fountain.

Install new high/low fountain. \$2,216

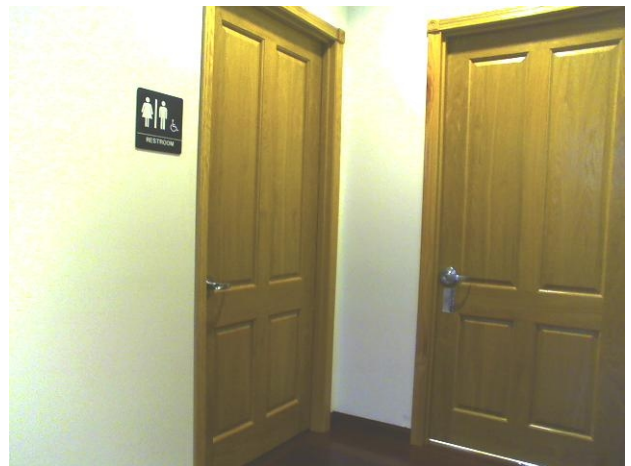
Restroom : No Visual Alarms

There are no visual warning devices in this area of the facility.

On-Site Finding None Found

ADAAG 4.28

CA 1114B.2.4

Install visual warning devices integrated with the facility's alarm system in all common areas such as hallways, general use rooms, and in accessible restrooms and other accessible rooms.

Install new audible/visual alarm. \$388
